Alwest 370 Superstructure Restoration

Article by Rob Farrow (rob.farrow@sympatico.ca) based on the 2001 cabin exterior restoration of the 1972 Alwest 370, "Catherine Ann".

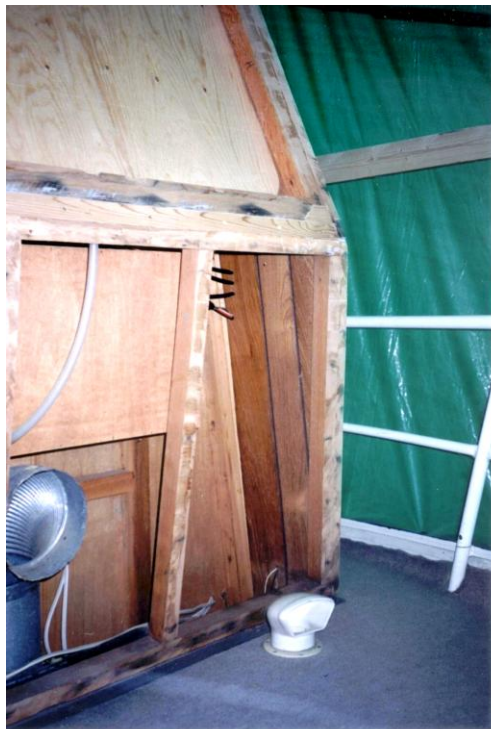
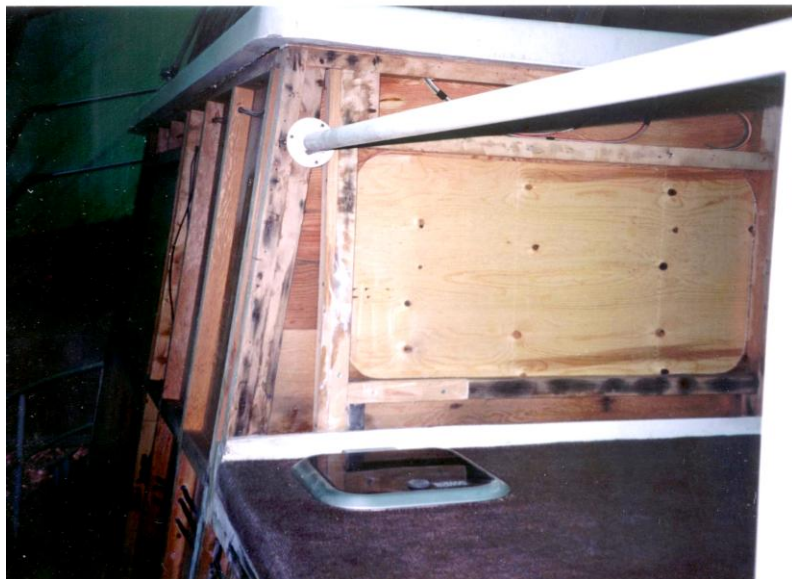
You are now looking at the Sitka spruce 2 x 2 frames. (some new frame sections are already installed in these pictures)

If your boat is like Catherine Ann, things are not as bad as they will initially look. In many places, the surface of the frame is blackened, and perhaps slightly deteriorated, but a surface cleanup with a coarse sanding disc to remove all of the old glue and poking with an awl, should show that most is still structurally sound and will hold new fasteners. There will be places where the frame has deteriorated significantly. Unless it has completely rotted away, removing the old frame pieces will be difficult to do without damaging the interior paneling. Since the end result will remain completely dry, I chose to sister new frames alongside any that were suspect but were not easily removable. I used clear cedar for the new frames since Sitka spruce was all but impossible to find. (In hindsight, to do this again I would use ash for the new frames)

Now is the time to make sure that none of the vertical frames are bowed. This is particularly important to the aft of the sliding door. On Catherine Ann, I fastened a temporary piece of steel flatbar along the side of the frame as a sanding/planing guide and in conjunction with a horizontal straight edge, used a power hand plane and a coarse sanding disc to bring everything flush. In a couple of places, where the wall was bowed in, I sistered a straight new frame permanently alongside the bowed one.

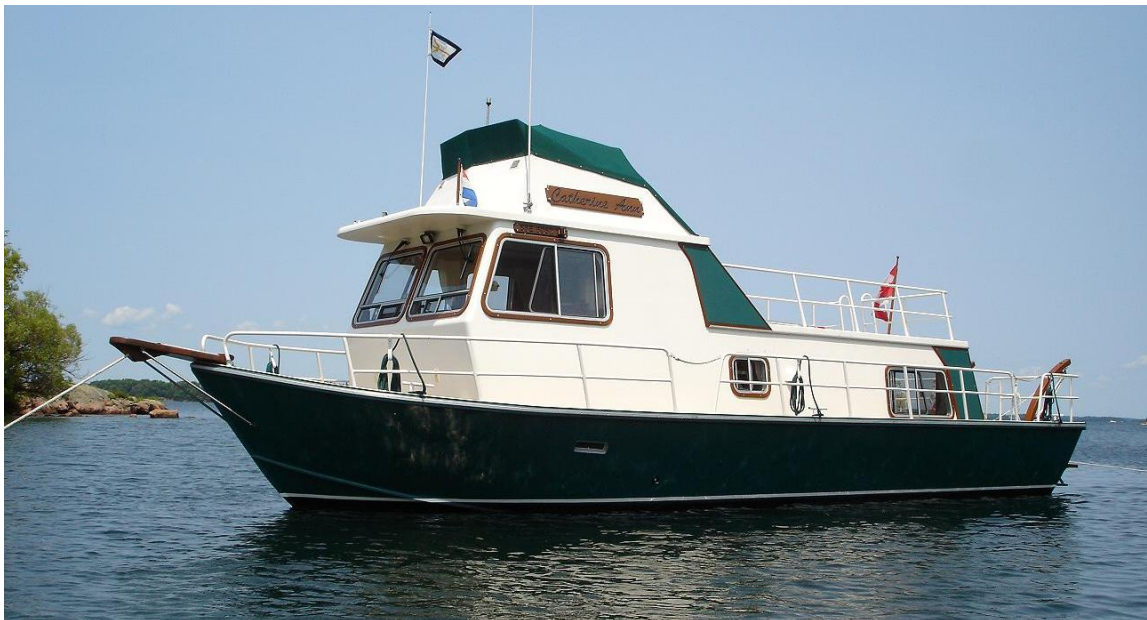
All that's left now is priming and painting and your Alvest 370 is as good as (or perhaps better than) new. The net result should be as apparently seamless as the superstructure on Catherine Ann. (2006 picture of the 2001 renovation)
