Alwest 370 Superstructure Restoration

Article by Rob Farrow (rob.farrow@sympatico.ca) based on the 2001 cabin exterior restoration of the 1972 Alwest 370, "Catherine Ann".

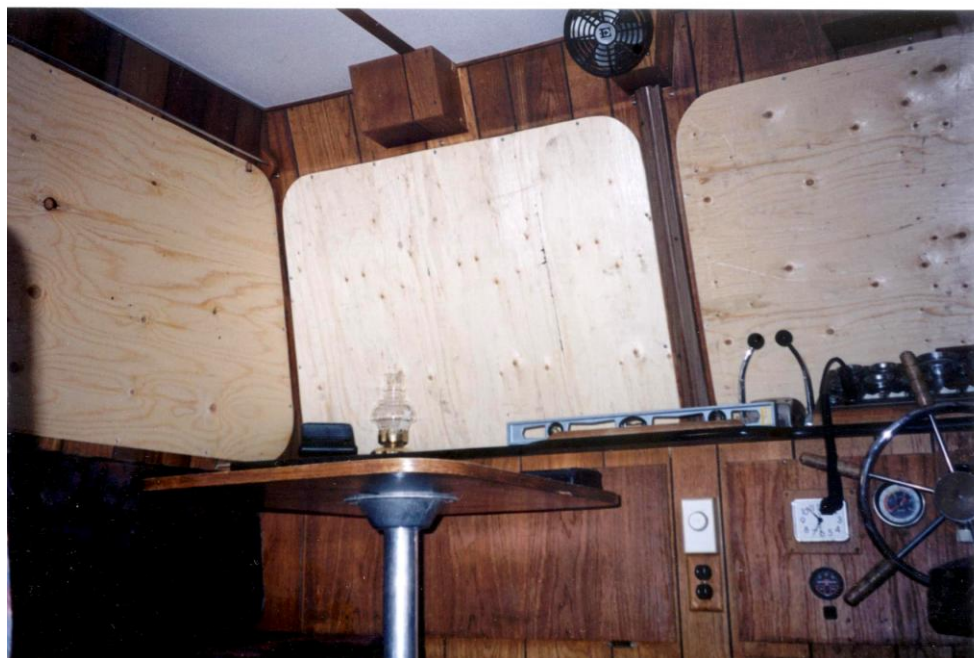
The windows have to be removed as complete assemblies, as there is no way to remove the glass first. The frames are not screwed or bolted to the structure, but are secured by the clamping force of the interior trim rings (already removed) thus they are now held in place only by the caulking. The tough part is getting the removal of each window started. Don't pry too heavily on the exterior aluminum flange as you will bend the edge and ruin the finish. Push and pry from the inside, and once you get one corner started the rest will come quite easily. For the larger windows, this is a two person job. The frames are light, but the tempered glass is heavier than you might think. Start with the smaller windows to get a feel for this process.

The next step is to remove the windows. Getting rid of the old sheathing and eventually preparing and painting the new exterior is going to be a dirty and at times dusty process. You will want to protect the interior of the boat as much as possible. Since the windows will be out for most of this process, I started by removing the interior window trim rings and using these as patterns to cut temporary window closeouts from 1/4” plywood. I could likely have used plastic sheeting, but during the fitting of the new sheathing, these covers will need to individually come on and off a few times, so this proved to be an easy and inexpensive solution. They also provide a little more “security” for the interior of the boat during the renovation process. The covers were screwed to the inside, close to the edges of the opening where the holes will be covered when the trim rings are reinstalled.
